Therapy of an infra-bony peri-implant defect

Successful regenerative treatment using modern alloplastic bone graft material

Dr Hussein Asaria, UK

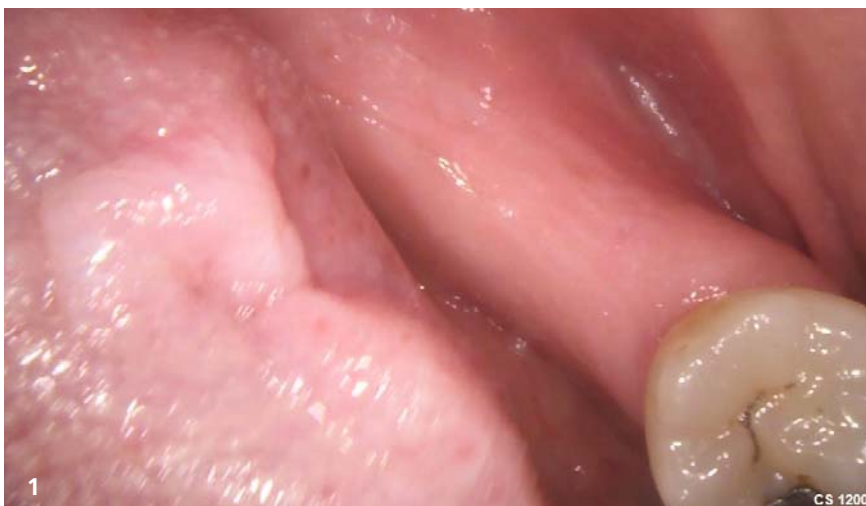
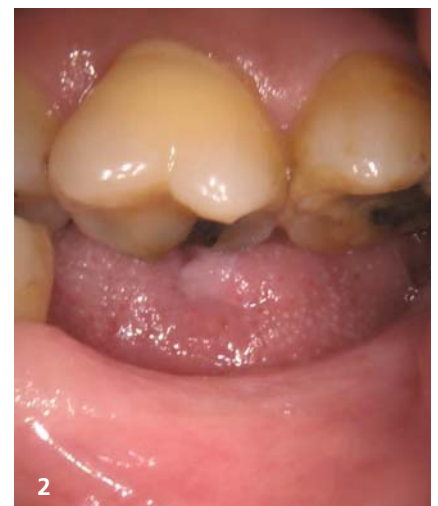
Figs. 1 & 2: Initial clinical situation.

In January 2022, a 58-year-old woman presented with a long-standing concern about her inability to bite effectively on her lower left side due to the absence of her first and second molars (Figs. 1 & 2). She expressed interest in exploring dental implant options to restore her bite functionality.

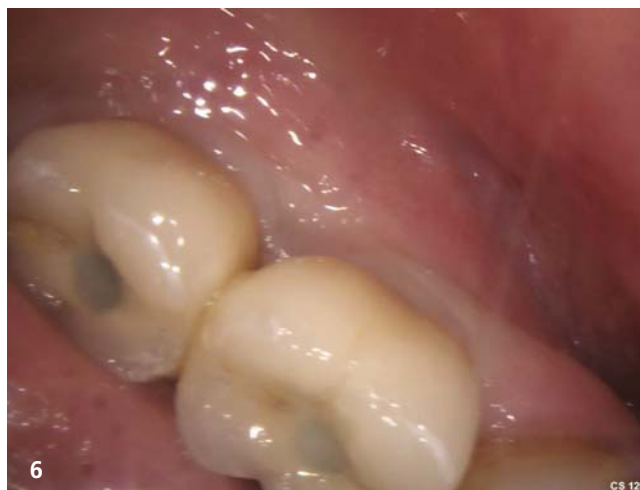
Fig. 3: CBCT scan for treatment planning.
Fig. 4: Implants at the time of placement.
Fig. 5: Radiograph taken during the impression phase.
Fig. 6: Condition of the tissues at the time of fit.

Her medical history revealed high blood pressure and borderline type 2 diabetes, for which she was regularly taking amlodipine and metformin. A cone beam computed tomography (CBCT) scan was conducted for planning purposes (Fig. 3). Subsequently, implant placement was performed three months later (Fig. 4). The patient was pre-medicated with 3g of Amoxicillin, and a full-thickness flap was raised to place two GM Helix Neodent implants, each 3.5 x 10 mm, with a torque of 45 Ncm. Healing abutments were also placed, and no grafting was necessary. The surgical procedure was uneventful, and the patient returned a week later for suture removal, with healing progressing as expected.

Four months post-implantation, multi-unit abutments (GM Mini Conical) were fitted, and impressions were taken for linked crowns (Fig. 5). The crowns were placed one month later (Fig. 6). Six weeks after crown placement, the patient was recalled for an assessment, which revealed no issues, with baseline probing depths around the implants being satisfactory.

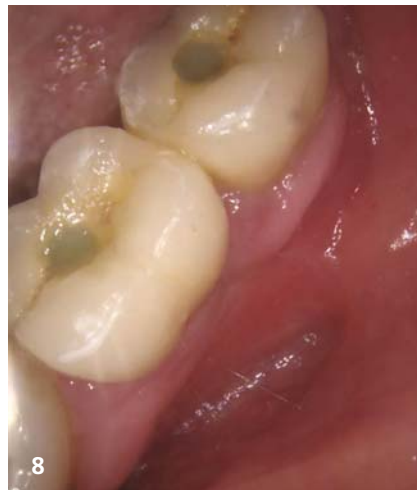
Fig. 7: Radiograph at nine months post-op. **Fig. 8:** Buccal swelling can be observed. **Fig. 9:** Removal of the restoration. **Fig. 10:** Three-sided flap revealing the defect.

However, seven months post-implantation, the patient reported a strange, swollen sensation in her gum over the past six weeks. Her general dentist prescribed Amoxicillin 500mg, to be taken three times daily for five days. Clinical examination and radiographs revealed bleeding on probing, suppuration, increased probing depths, and progressive bone loss around implant #37 only (Figs. 7 & 8).

To address this, the patient was instructed to follow an intense oral hygiene regimen, including interdental brushing and salt rinses, for two weeks. Following this regimen, the restoration was removed (Fig. 9), and the #37 abutment was replaced with a flat cover screw. A full-thickness three-sided flap was performed to avoid disturbing implant #36 (Fig. 10). The granulation tissue was meticulously removed using hand instruments and EthOss® degranulation burs, and the implant was cleaned with a stainless steel hand curette. After thoroughly removing the infected tissue, the implant surface was disinfected with 6% hydrogen peroxide gel for two minutes, followed by saline rinsing. This decontamination process was repeated five times (Figs. 11–16).

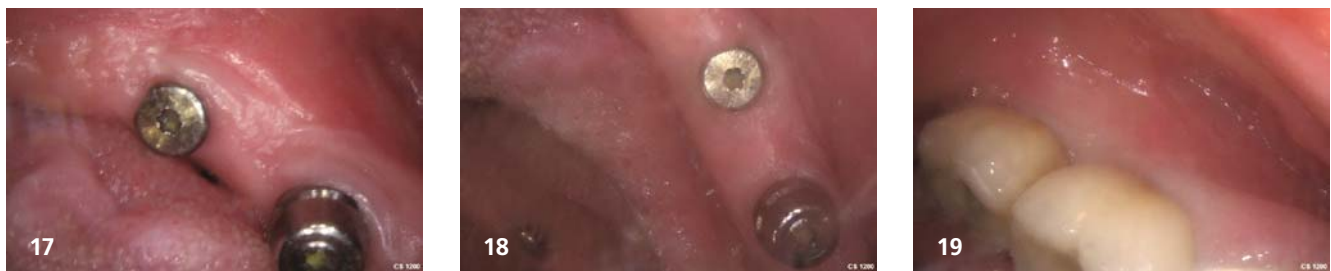
Figs. 17 & 18: Healing progress around the healing abutment. **Fig. 19:** Placing of the original restoration. **Fig. 20:** Condition of the tissues at the time of re-fit. **Fig. 21:** Radiograph taken at re-fit. **Fig. 22:** Condition of the tissues at the six-month review. **Fig. 23:** Lingual tissue condition at the six-month review. **Fig. 24:** Radiograph taken at the six-month review.

Four months later, the patient returned for a follow-up, reporting no pain or issues. Probing depths around implant #37 were 112/111 around the protection cylinder, and around implant #36 were 101/101 around the healing abutment. The healing abutment was replaced with the initially used MUA, and the same restoration was reattached (Figs. 17–24).
